PLAIN NINE DAM

NDI I.D. NO: 520

6 PHASE I INSPECTION REPORT  
NATIONAL DAM INSPECTION PROGRAM.

Plain Nine Dam (NDI 520), Susquehanna  
River Basin, Blair Gap Run, Blair County,  
Pennsylvania. Phase I Inspection Report.

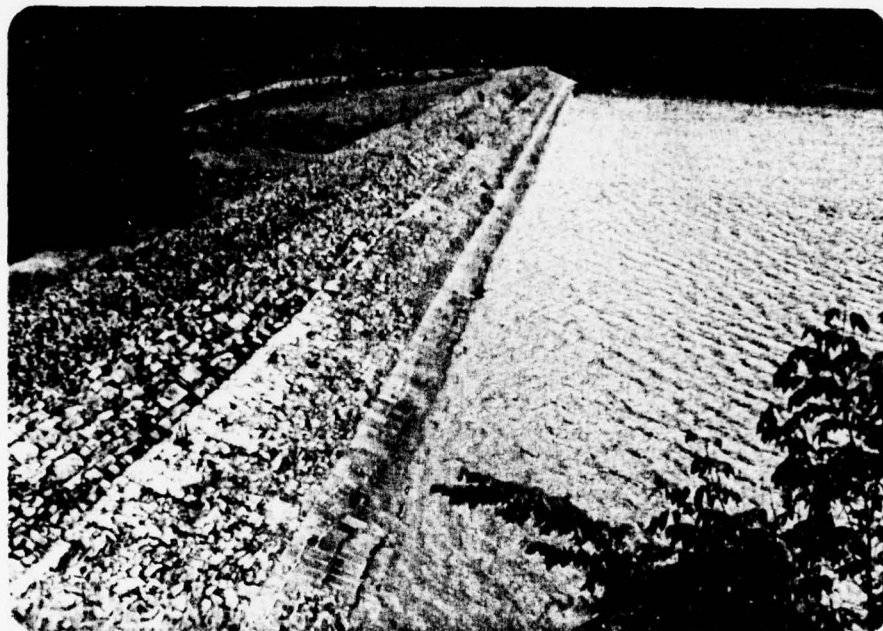
Upstream Face

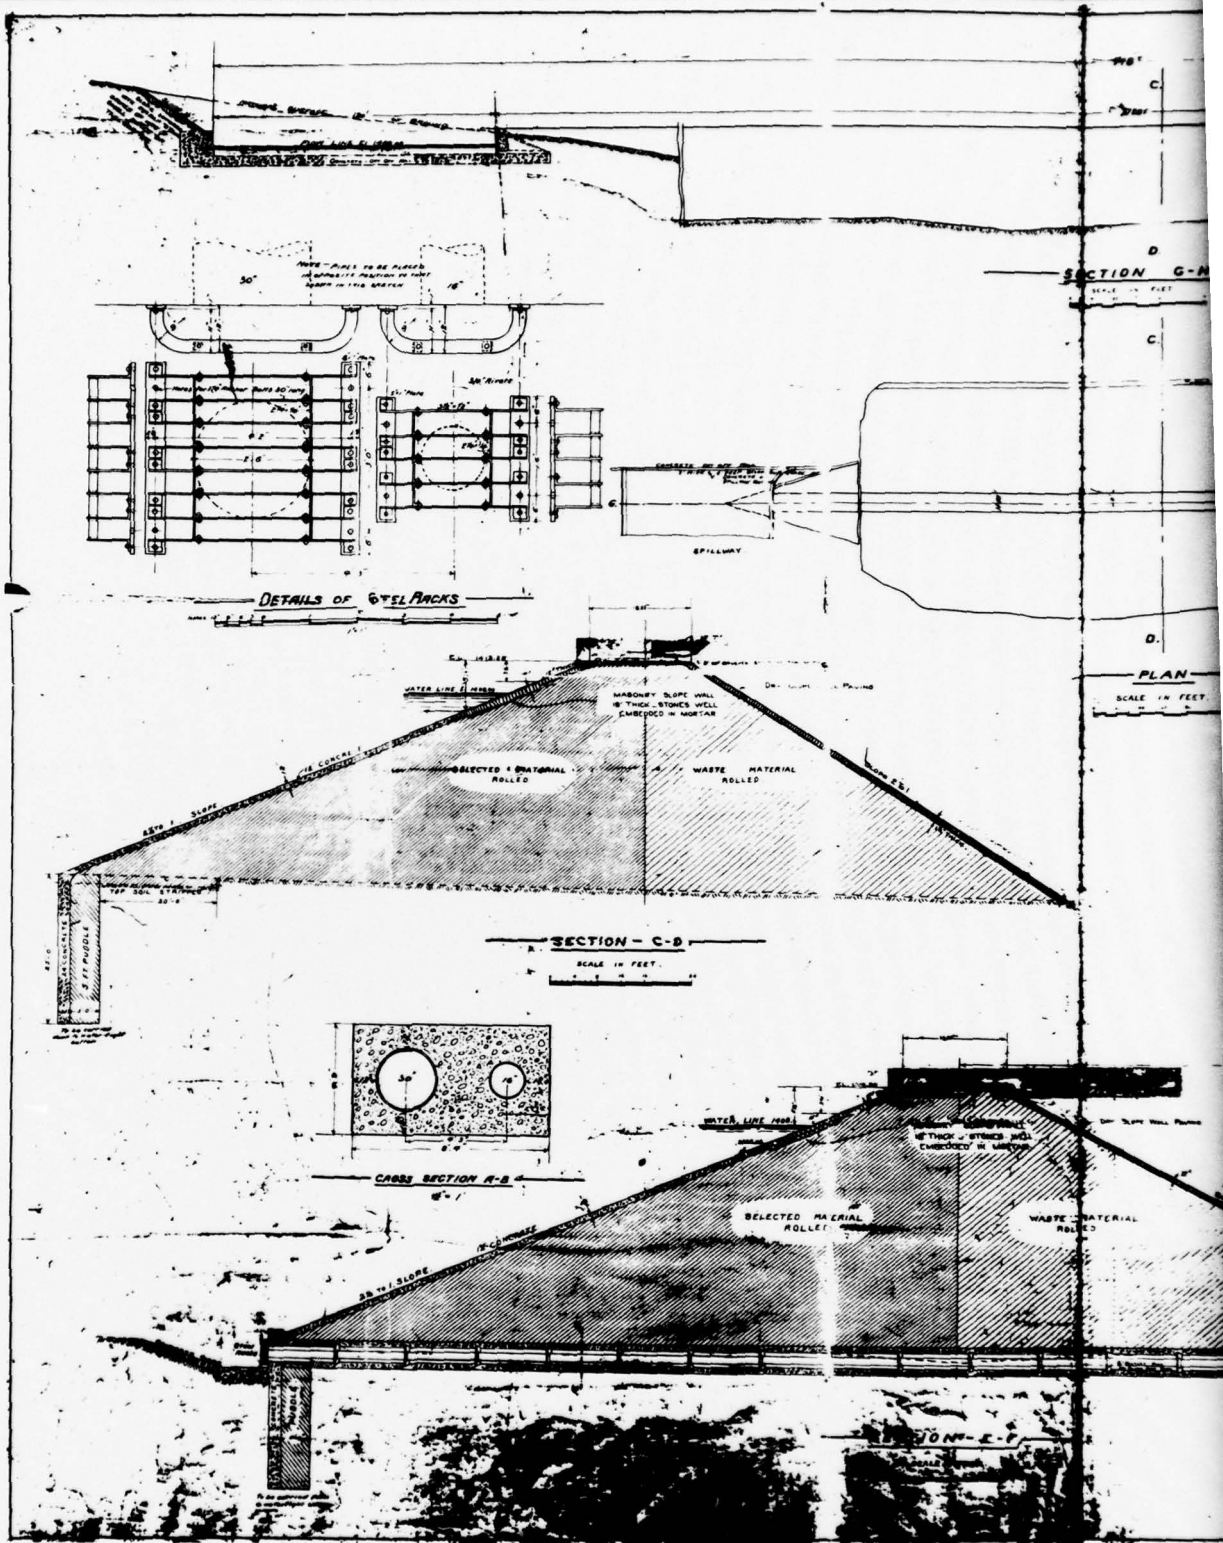
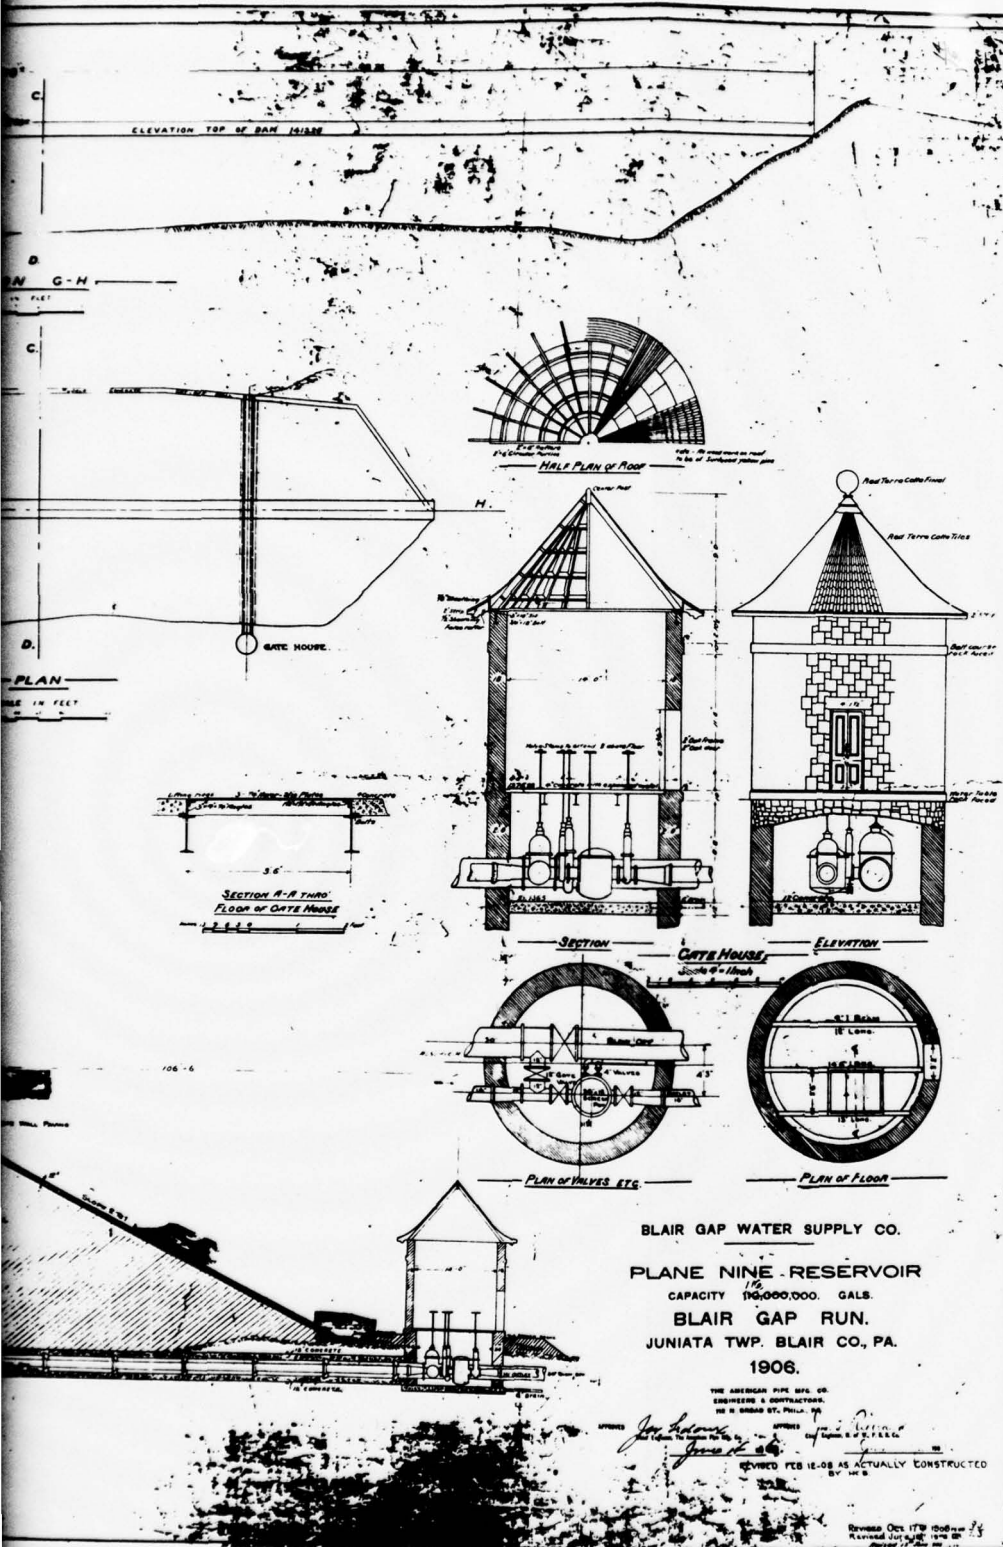
PLATE 2

- (a) As designed, the dam is essentially a homogeneous embankment with a "puddle" clay cut-off wall at the upstream toe of the dam. In the design drawings, two different zones are identified (Plate 2): "selected material rolled" in the upstream half of the embankment and "waste material rolled" in the downstream half of the embankment.

- (b) The embankment was designed to have a two and one-half to one (2.5:1) (horizontal to vertical) slope upstream and a 2:1 slope on the downstream face (Plate 2). The downstream face is protected by 12-inch hand-placed riprap. The upstream face is lined with a 12-inch-thick concrete slab starting 3 feet below the normal pool level (Elevation 1405) and extending down to the toe to join a 2-foot-thick concrete cutoff wall backed with a 5-foot-thick puddle clay seal, extending from abutment to abutment. Above the concrete slab, the upstream face is protected by an 18-inch-thick rubble-masonry slab.

- (c) A design drawing (Plate 2) indicates that the concrete cutoff wall and puddle clay backing were to be extended to "watertight material."
- (d) No information was found relative to the subsurface investigation at the site. The 1914 inspection report states that three casings were found at the toe area of the dam, indicating that a subsurface investigation was conducted at the site.

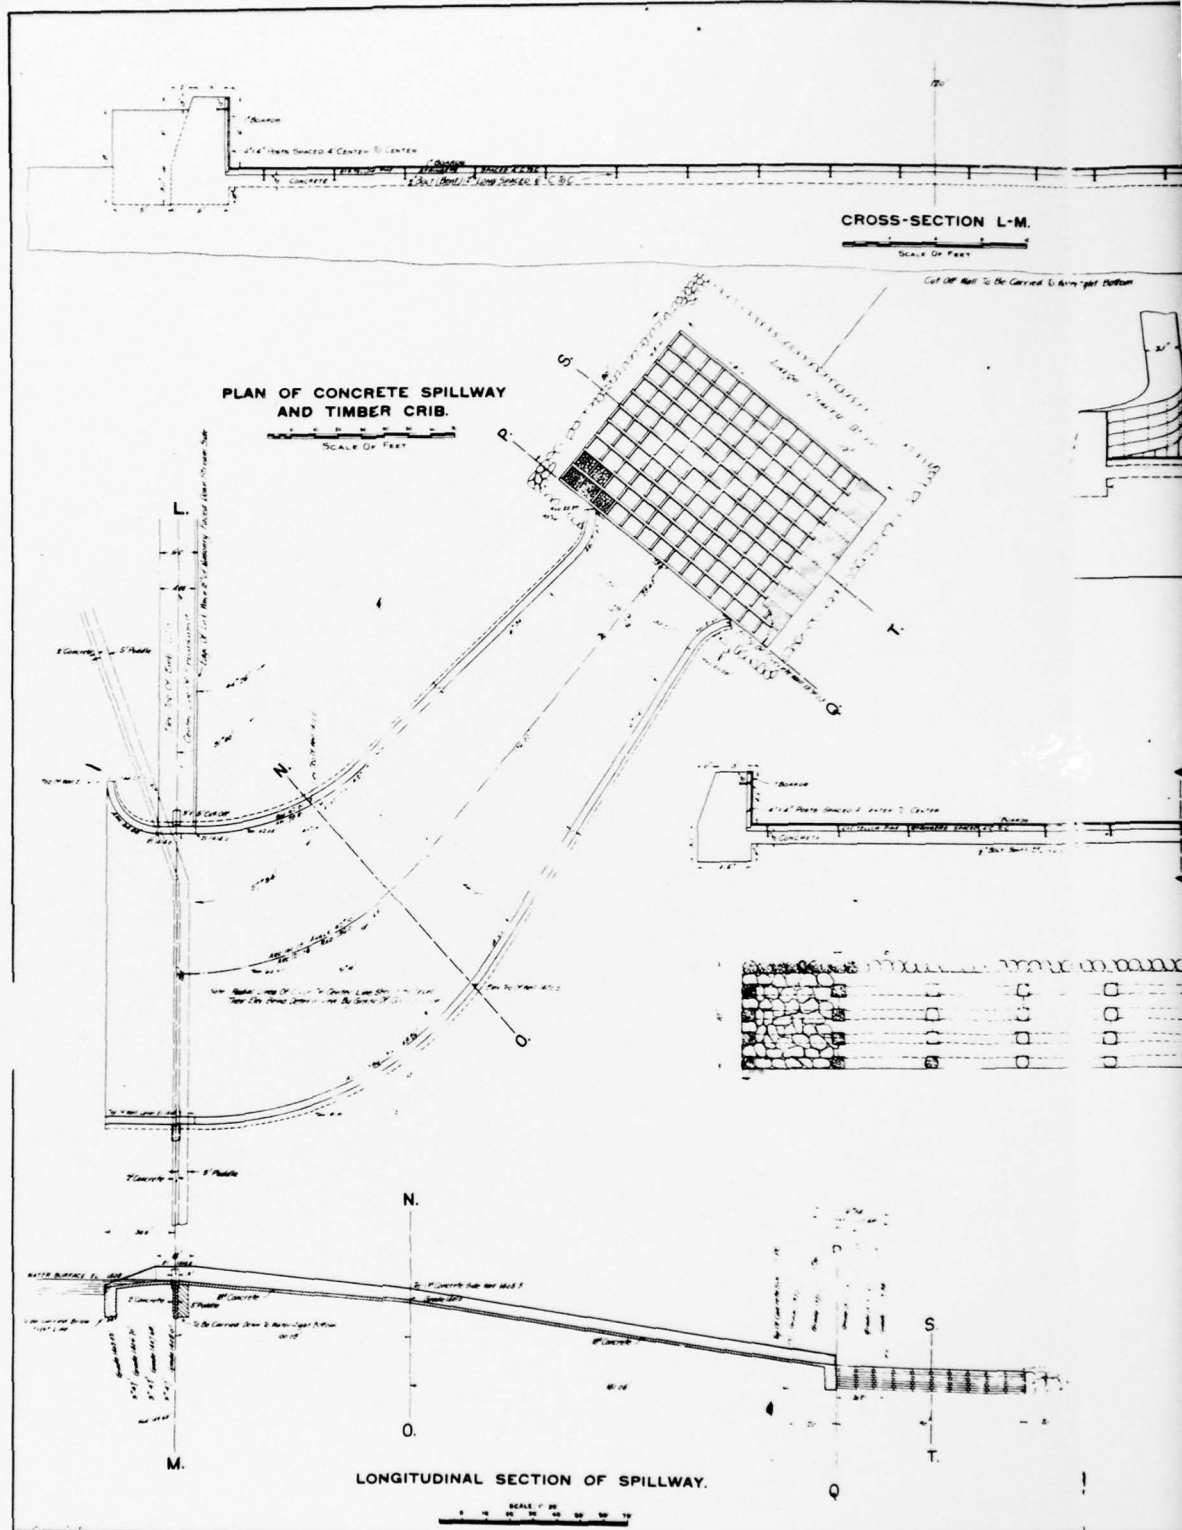
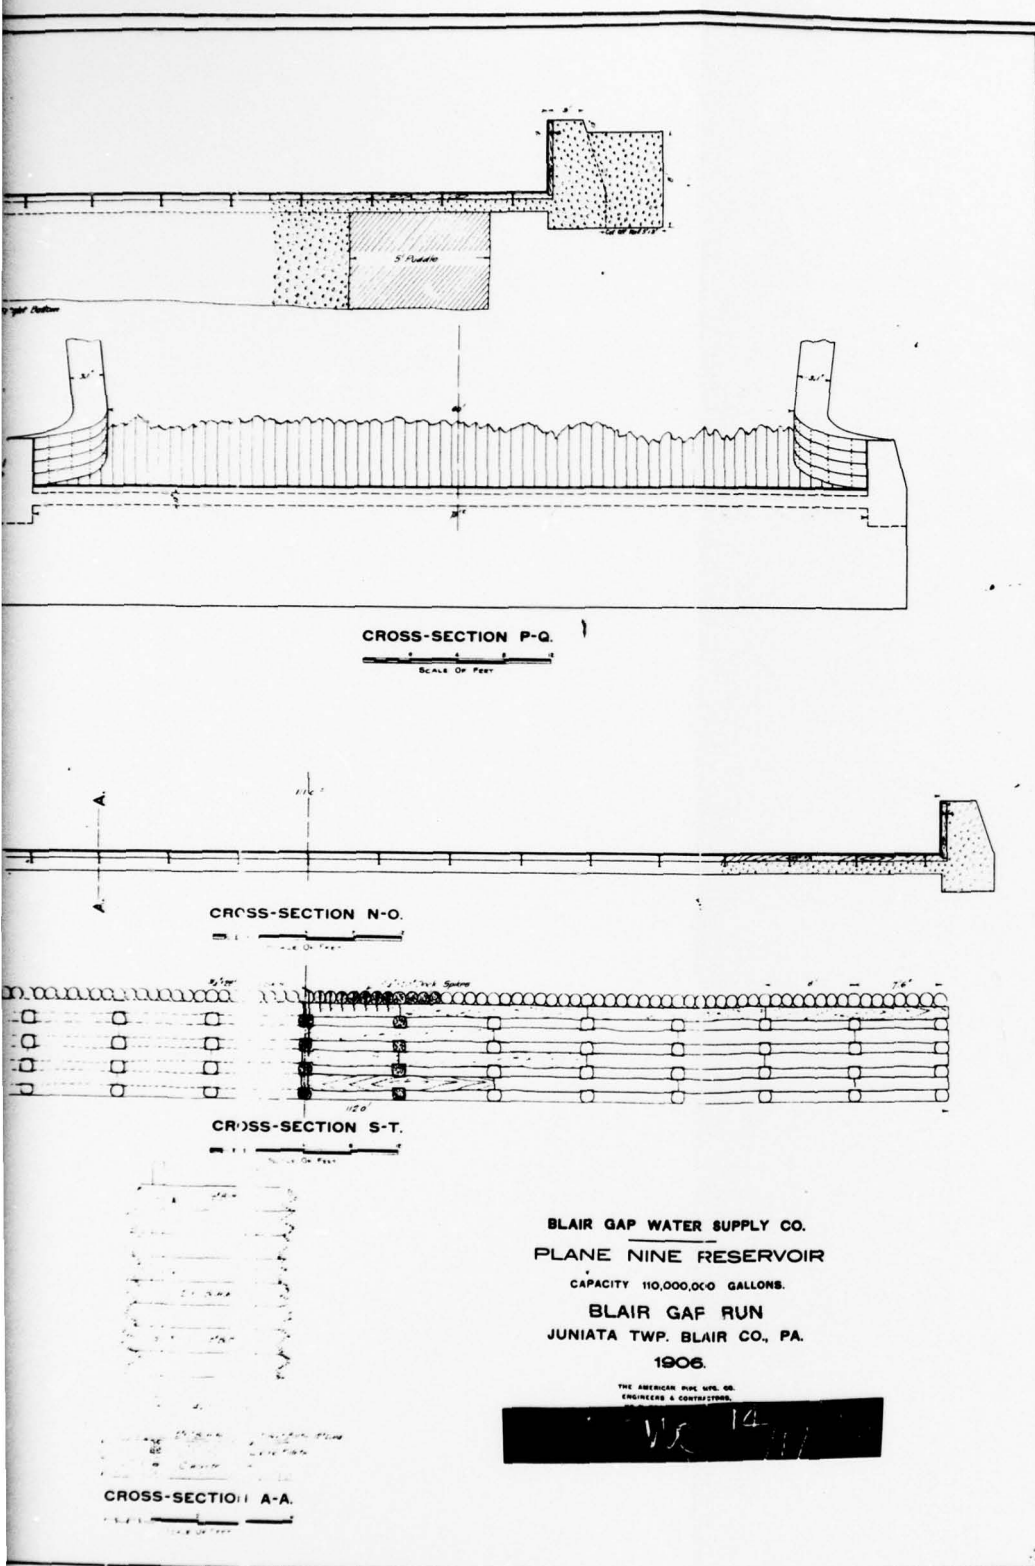
PLATE 3

(2) Appurtenant Structures. The appurtenant structures for the dam consist of an uncontrolled spillway and outlet works. The spillway structures consist of a broad-crested weir spillway, a discharge channel, and a timber energy dissipator. The details of the spillway structures are shown in Plate 3. The outlet works consist of 30-inch supply lines and a 16-inch blow-off pipe. Descriptions of the appurtenant structures are included in Section 1.2.
